# Synergistic Erosion/Corrosion of Superalloys in PFB Coal Combustor Effluent

S. M. Benford, G. R. Zellars, and C. E. Lowell  
*Lewis Research Center*  
*Cleveland, Ohio*

Prepared for the  
Eighty-second Annual Meeting of the American Ceramic Society  
Chicago, Illinois, April 28-30, 1981

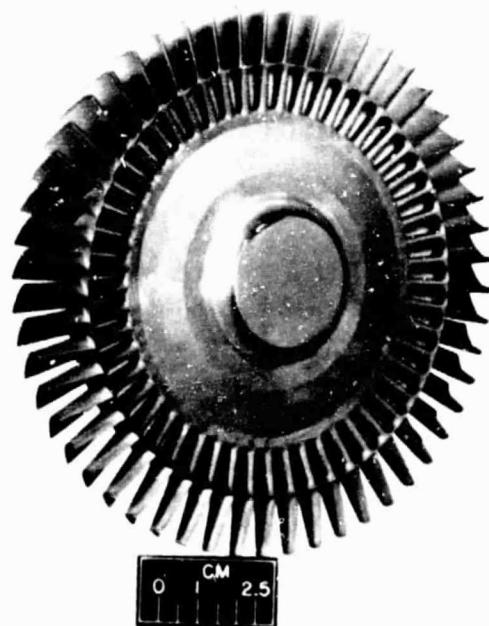
A turbine rotor is shown in Fig. 4 and test conditions are shown in Table I. A single stator passage guided the hot gases onto about three blades at 6 percent partial admission. The blades were therefore exposed to the eroding particles for about 1.5  $\mu\text{sec}$  out of each revolution (25  $\mu\text{sec}$ ). (Actual erosive exposure time may be calculated by multiplying the test time by 0.06.) Heavy particle separation occurred both in the stator and during passage through the rotor, producing a nonuniform distribution of erosion on the blade surface. The relative gas velocity at the rotor inlet was about 300 m/s (1000 ft/s), and the gas temperature ranged from 690° to 780° C (1350° to 1450° F). Rotor materials were Alloy 713 LC (wt.% Cr-12, Al-6.1, Ti-0.6) and IN792 + Hf (wt.% Cr-12.4, Al-3.1, Ti-4.5), both nickel-base superalloys.

Figure 4. - Integrally bladed turbine rotor.
